FLASH

actual lines about submarine hazards

July-September 2015 Edition

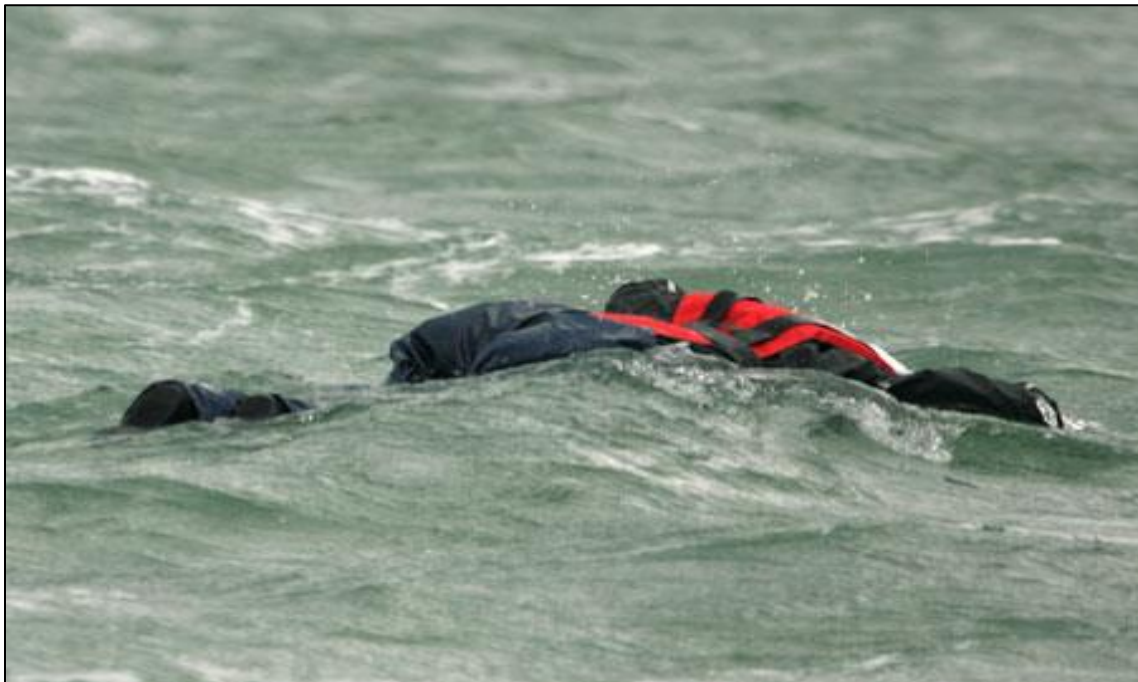
**PROPER LIFE PRESERVER PMS
COULD PRESERVE YOUR LIFE**

9. (Deck) Mk-1 Auto-Inflatable Life Preservers (SSN/SSBN/SSGN) Recent instances of the Mk-1 failing to inflate when personnel fell overboard in-port have raised concerns about the performance of PMS on these preservers. We will inspect 100% of Mk-1 life preservers during safety assessments to include ORM evolution evaluations similar to PMS monitoring. Additionally, SUBLANT is evaluating the discrepancies noted during PMS monitors.
